CONNECTICUT RIVER BASIN  
VERNON, CONNECTICUT

# ALDON MILL POND DAM CT 00622

## PHASE I INSPECTION REPORT NATIONAL DAM INSPECTION PROGRAM

Identification Number:	CT 00622
Name:	Aldon Mill Pond Dam
Town:	Vernon
County and State:	Tolland County, Connecticut
Stream:	Tankerhoosen River
Date of Inspection:	November 6, 1980

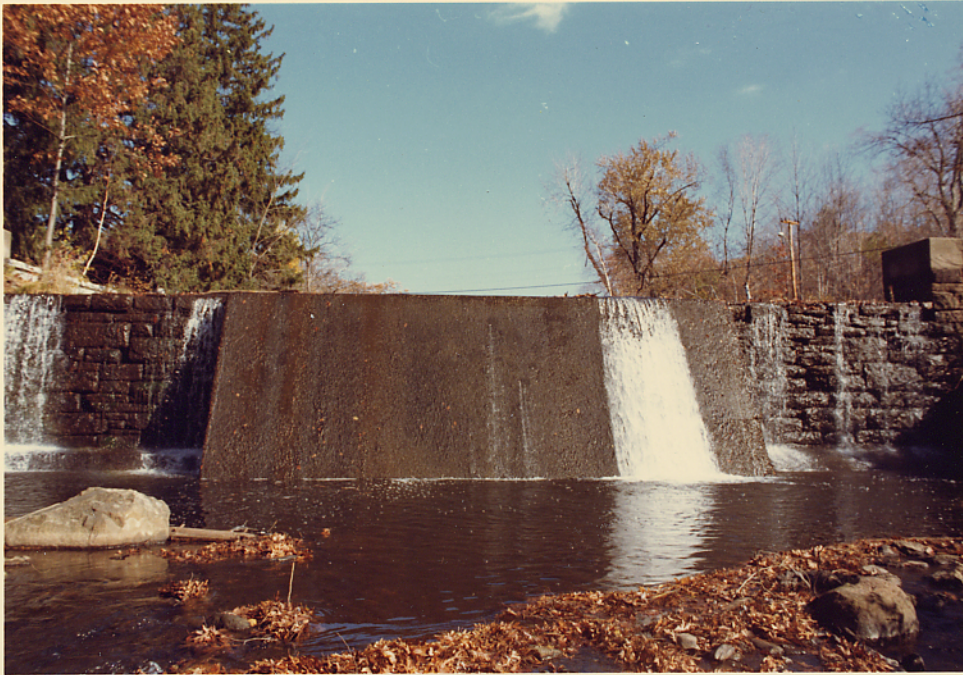
PHOTO 1  
SPILLWAY

b. Dam - The dam is a stone masonry and earth embankment structure with a concrete buttress covering a portion of the downstream face as shown on the Overview Photo and Photo 1 (Appendix C). The abutments are stone masonry capped with concrete and are in good condition (Photos 3 and 4). There is a 36 inch diameter stump adjacent to and upstream of the northwest abutment and there are several small trees growing from the downstream face of the embankment and the northwest abutment (Photos 3 and 7). Stones are missing from the masonry of the downstream face at several locations (Photos 2 and 4, see Photo Location Plan - Plate 3 for location). No seepage was observed. The upstream earth embankment is completely underwater.

c. Appurtenant Structures - The spillway is 71.5 feet long and consists of a 3-foot concrete cap on top of the stone masonry (Photos 1 and 3). The concrete cap is cracking near the southeast abutment. The cracks are minor. They range in length from 1 to 2.5 feet and are approximately 1/16 inch wide. There are leaves and debris along the length of the spillway.

The middle section of the spillway is supplemented by a concrete buttress projecting from the downstream masonry face and sloping at 1:2.5 to the toe of the dam (Photo 1). The width of the weir increases to 10 feet at this location. The concrete is in good condition with only minor spalling.

- (1) Remove brush from around the embankments;
- (2) Clear the spillway of debris;
- (3) Repair cracked and spalled concrete;

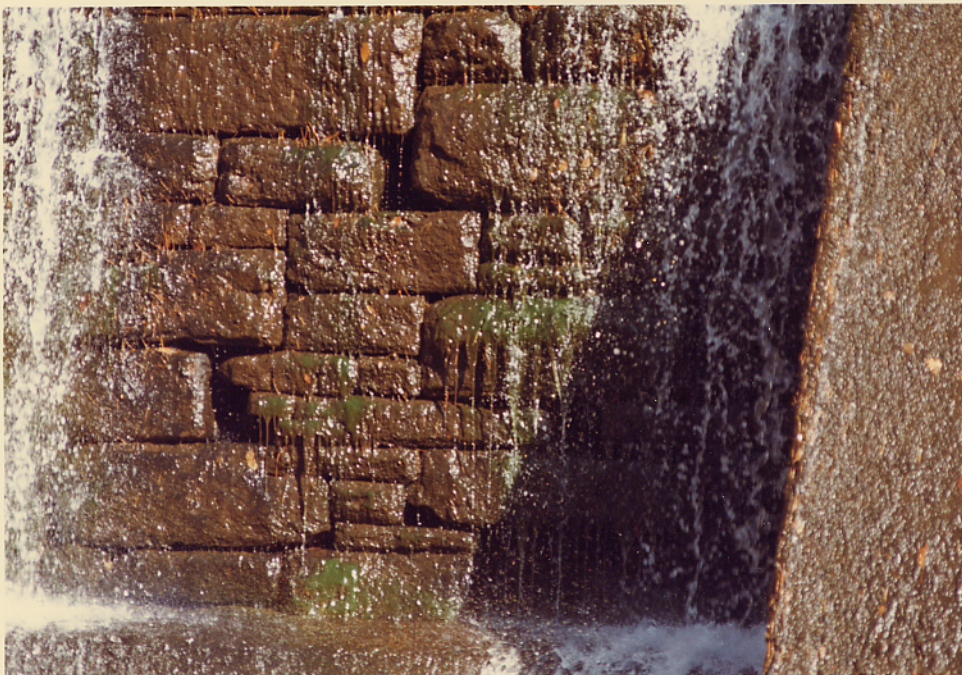
PHOTO 2  
MASONRY BELOW SPILLWAY

The general structural stability of the dam is good. The vertical, horizontal and lateral alignments are good; however, in a few places stones are missing from the downstream face. Small trees are growing from the downstream masonry face below the northwest abutment and on the upstream face of the northwest abutment. A large stump is at the base of and partly in the northwest abutment. The concrete buttress is in good condition and provides additional support. The upstream earthen face is completely under water. There is minor cracking on a portion of the concrete spillway cap and some minor spalling of the concrete buttress.

AREA EVALUATED	CONDITIONS
<u>DAM EMBANKMENT</u>	
Crest Elevation	208.5 (NGVD)
Current Pool Elevation	203.2 (NGVD)
Maximum Impoundment to Date	Unknown
Surface Cracks	Several stones missing from face of dam below spillway
Pavement Condition	N/A
Movement or Settlement of Crest	None
Lateral Movement	None
Vertical Alignment	Good
Horizontal Alignment	Fair - some stones protruding from face of dam below spillway
Condition at Abutment and at Concrete Structures	Fair - large stump and small tree adjacent to northwest abutment
Indications of Movement of Structural Items on Slopes	N/A
Trespassing on Slopes	Problem
Vegetation on Slopes	Brush and small trees
Sloughing or Erosion of Slopes or Abutments	Negligible
Rock Slope Protection - Riprap Failures	N/A
Unusual Movement or Cracking at or near Toes	None
Unusual Embankment or Downstream Seepage	None observed
Piping or Boils	None
Foundation Drainage Features	None
Toe Drains	None

b. The effect of the missing stones from the downstream face should be investigated and if it is deemed necessary, the stones should be replaced.

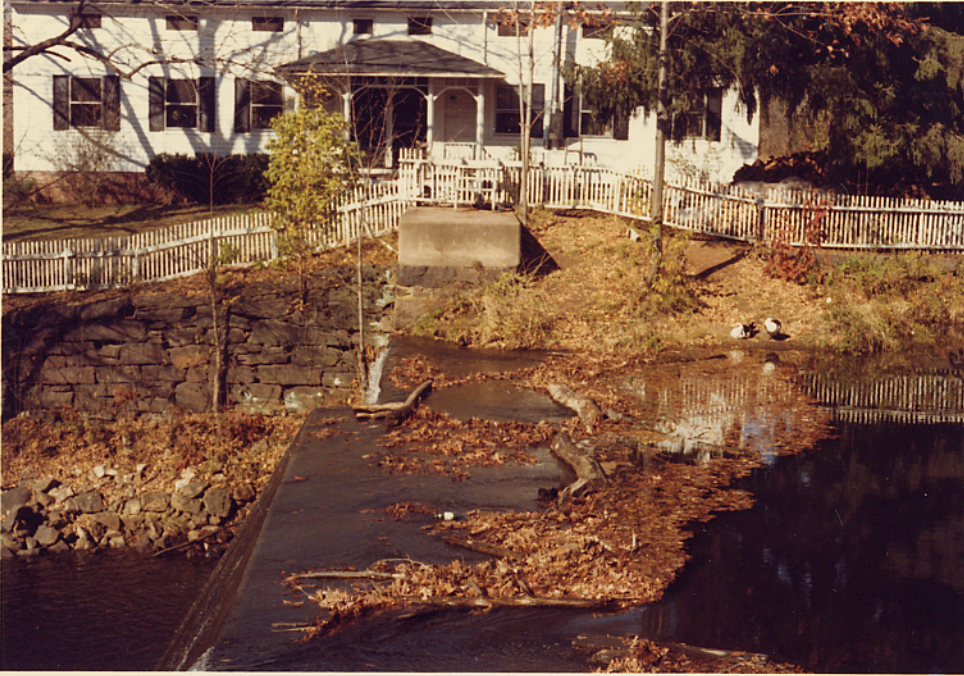
PHOTO 3

NORTHWEST ABUTMENT

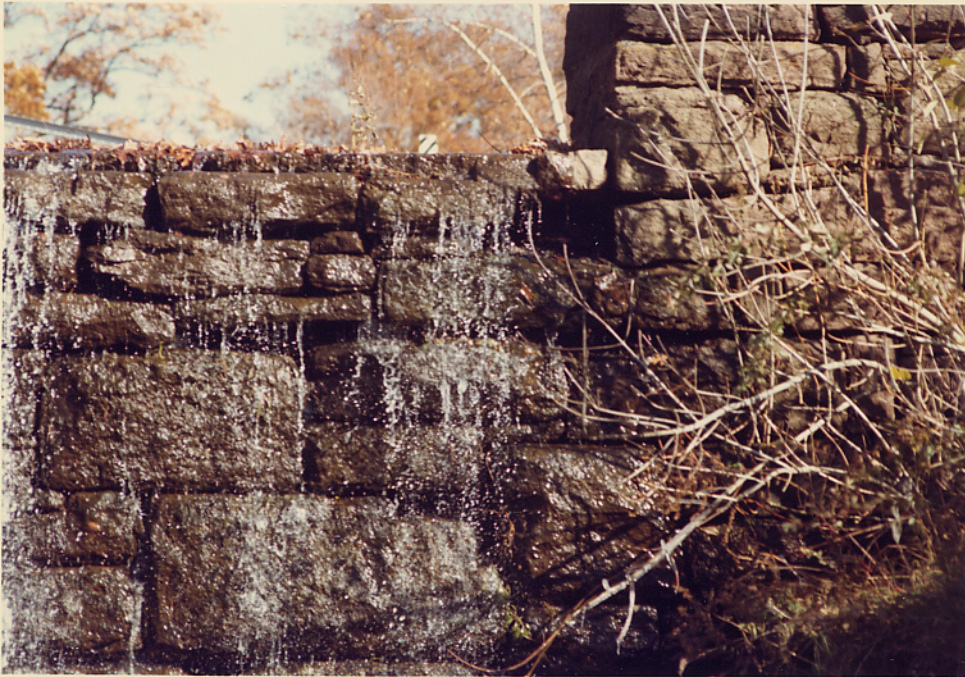
PHOTO 4

SOUTHEAST ABUTMENT - DOWNSTREAM MASONRY

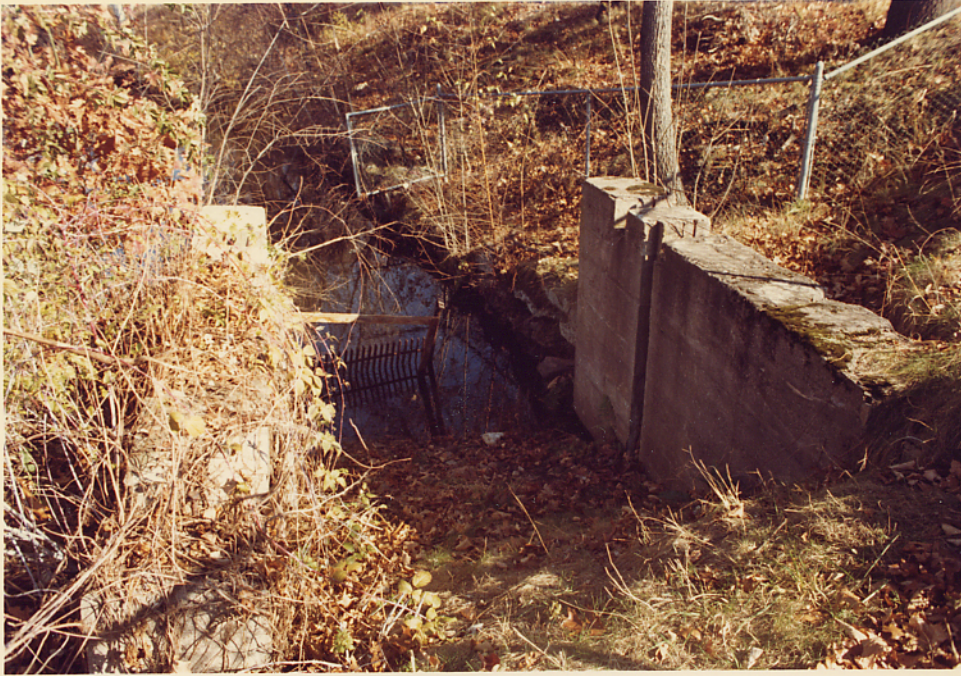
PHOTO 5

There is a concrete inlet structure to the southeast of the dam with a bar rack at the entrance. It has been filled in with dirt and debris covers the gate. The sluiceway leading to a downstream factory has also been abandoned and filled in. There is no low-level discharge pipe. There is, however, a 30 inch pipe gravity fed into the downstream factory where the water is pumped into a water tower for fire protection. When in operation, the drawdown rate out of the tower is 1,000 gpm.

INLET STRUCTURE - LOOKING UPSTREAM

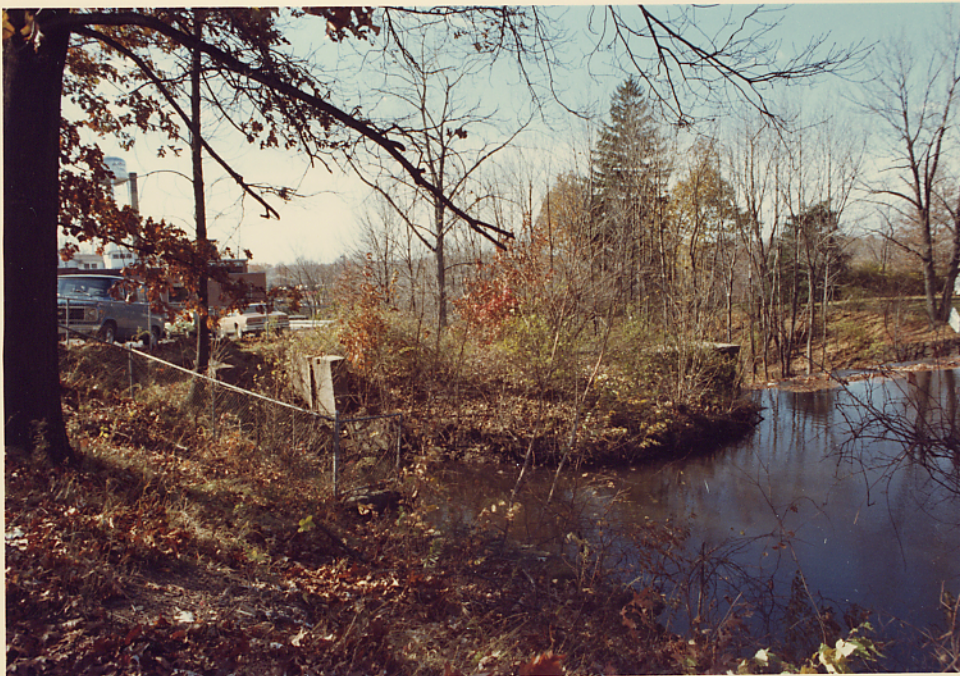
PHOTO 6

INLET STRUCTURE - UPSTREAM FACE OF DAM
